ANALYSIS REPORT

Analysis number: P-140314F32
Client: Ecoventur
Analysis period: 14-03-2014/24-04-2014
Test Description: Accelerated Thermal Degradation

M1. Bag yellow-blue, 0.005 inches.

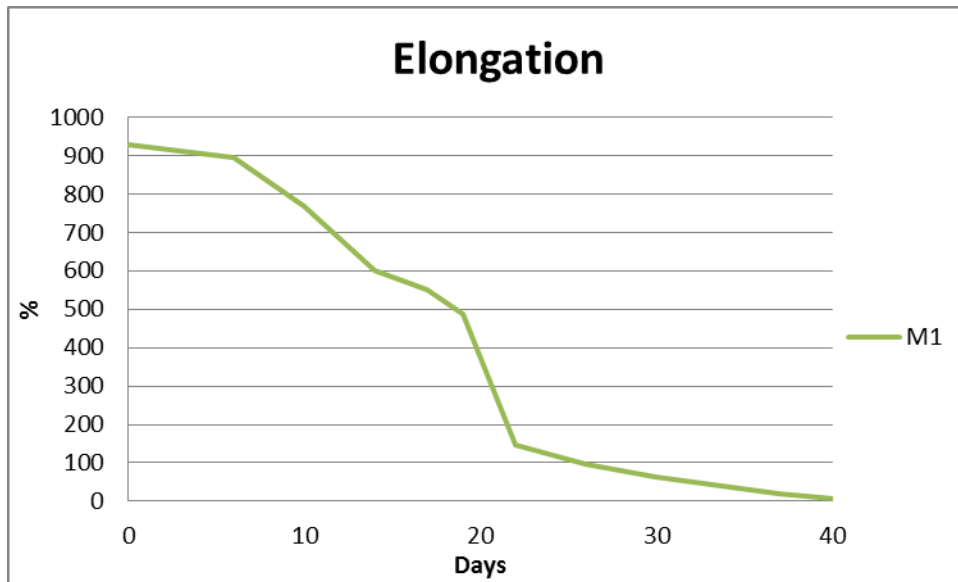
MECHANICAL PROPERTY

Days in the oven	Elongation (%)
	M1
0	928.10
6	894.63
10	768.78
14	600.37
17	552.25
19	486.94
22	147.28
26	95.53
30	61.74
37	20.63
41	4.15

It is considered that the period of useful life ends by losing more than 50% of the initial elongation. Therefore, we determined a **shelf life time of 3 years and 11 months**.

Based on ASTM D5510-94 is considered that the sample has reached its accelerated degradation, when it support less than 5% of elongation that happened after 41 days of study therefore we concluded that this sample has a **degradation time of 6 years with 8 months**.

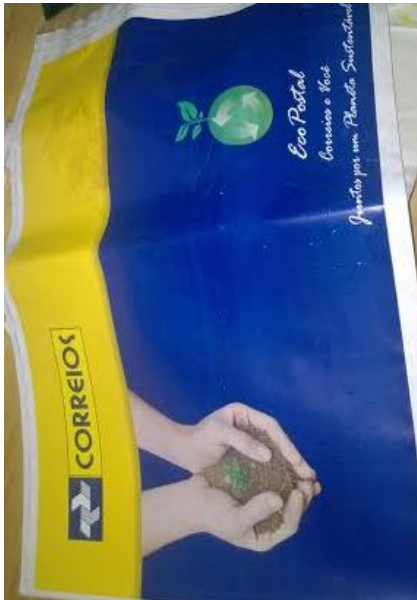
Illustration 1. Sample before the study began

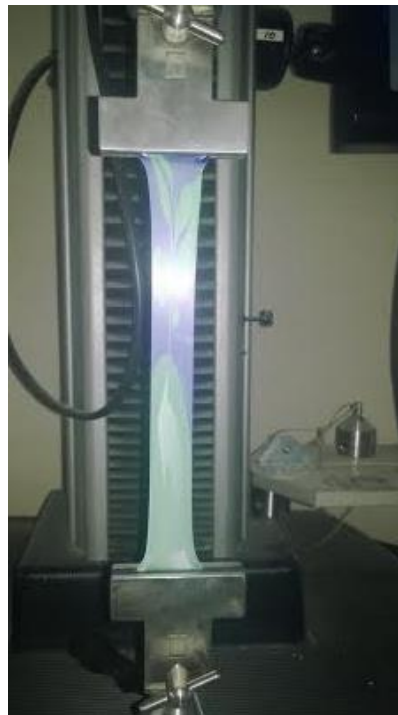
Illustration 2. Sample in the universal machine "elongation test".
